Case 311 : Narrative

Case Vehicle (A): 1999 Mazda
Type: 626 LX, 4-door sedan
Driver: 25-year-old female
CDC: 12-FDEW-2

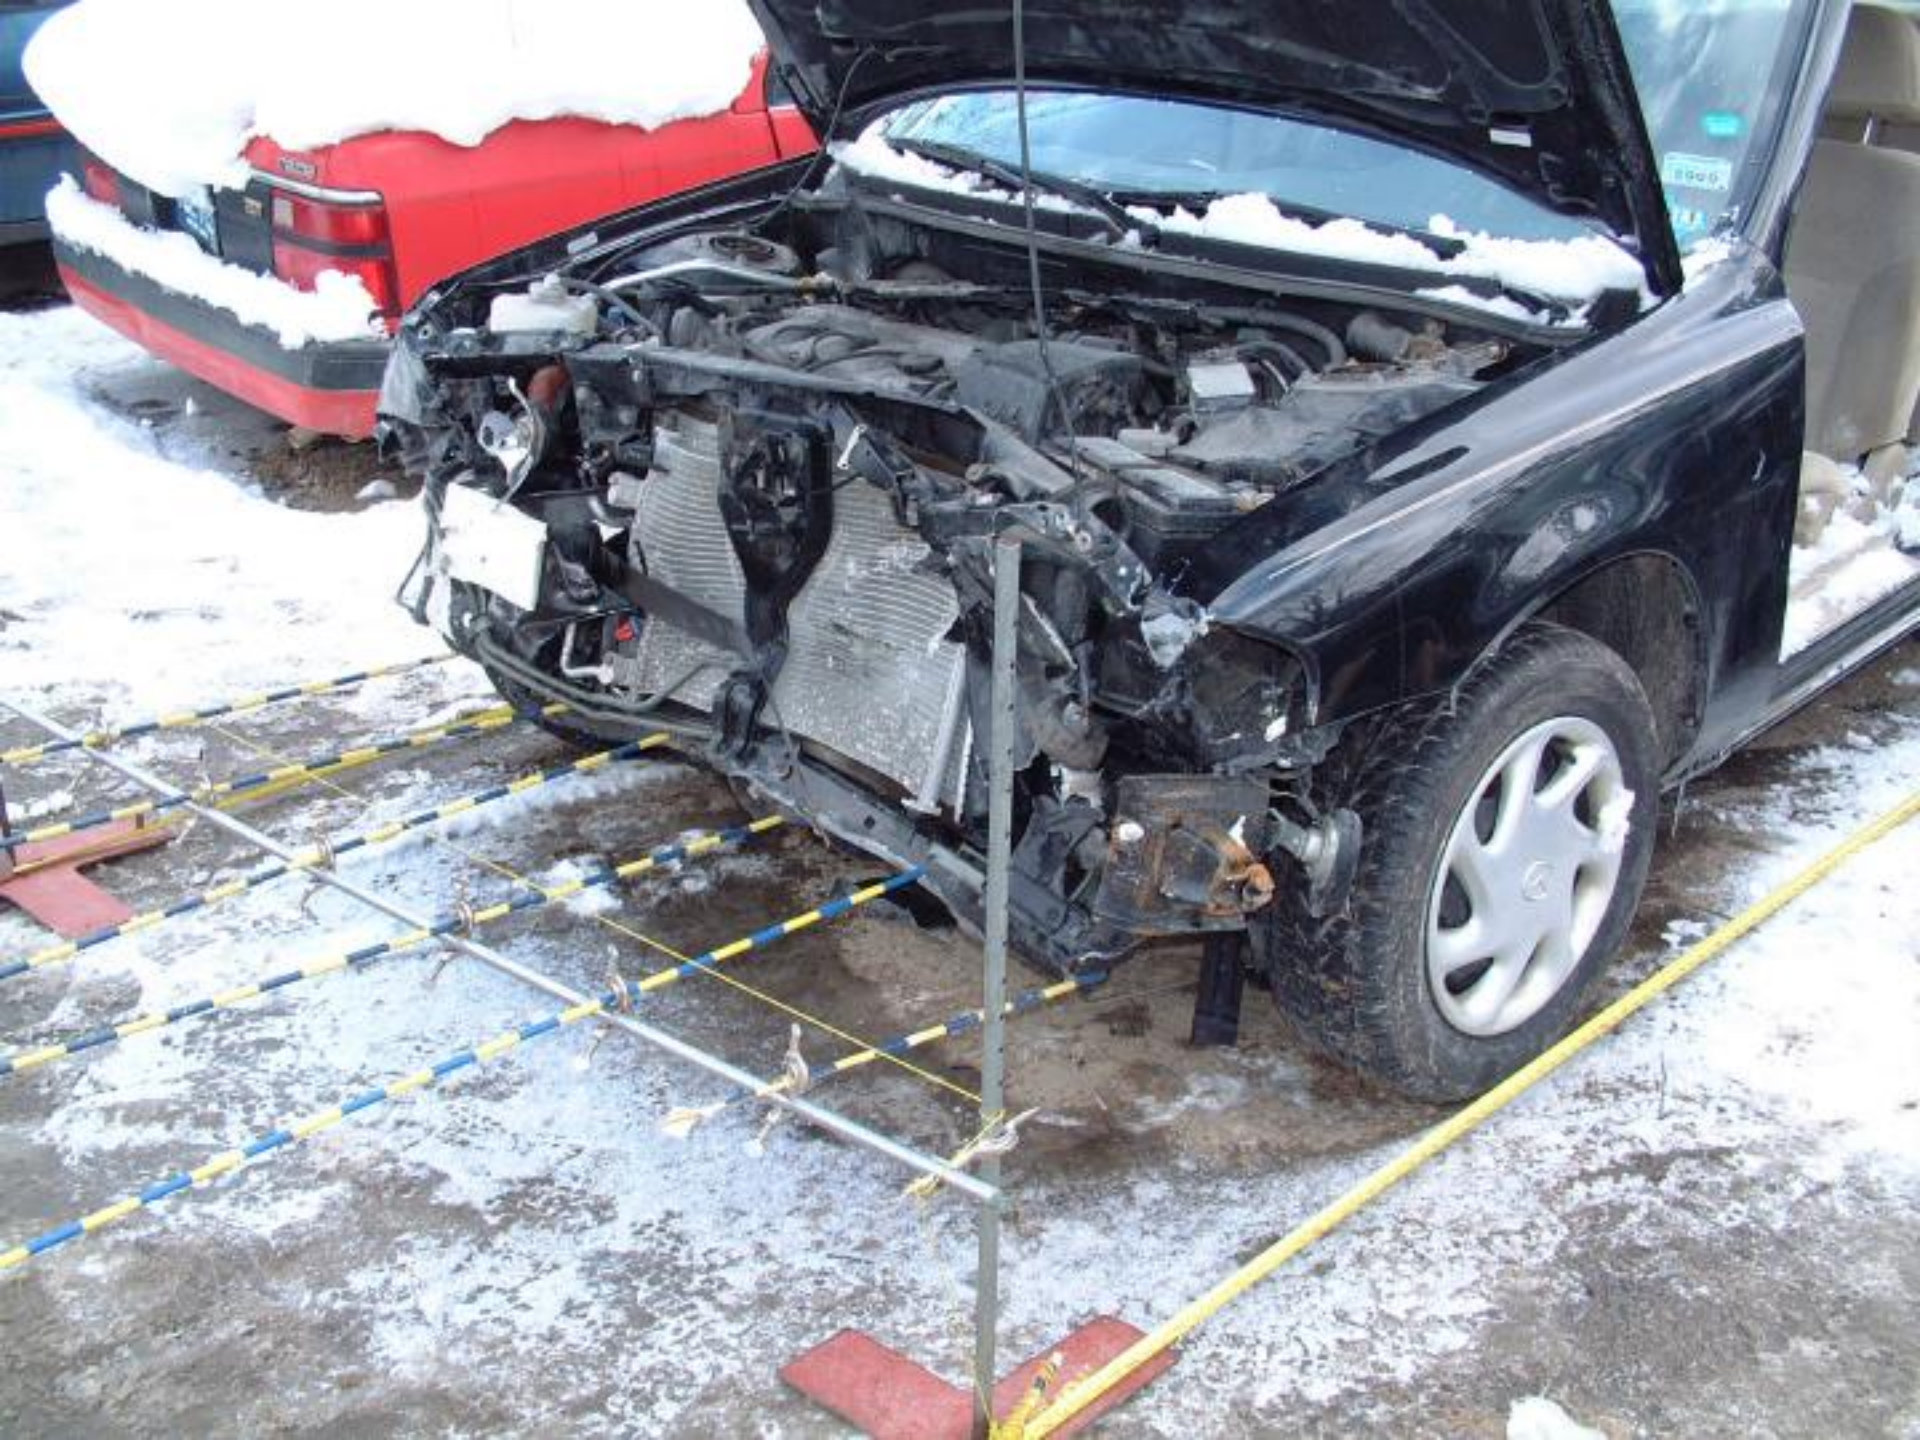
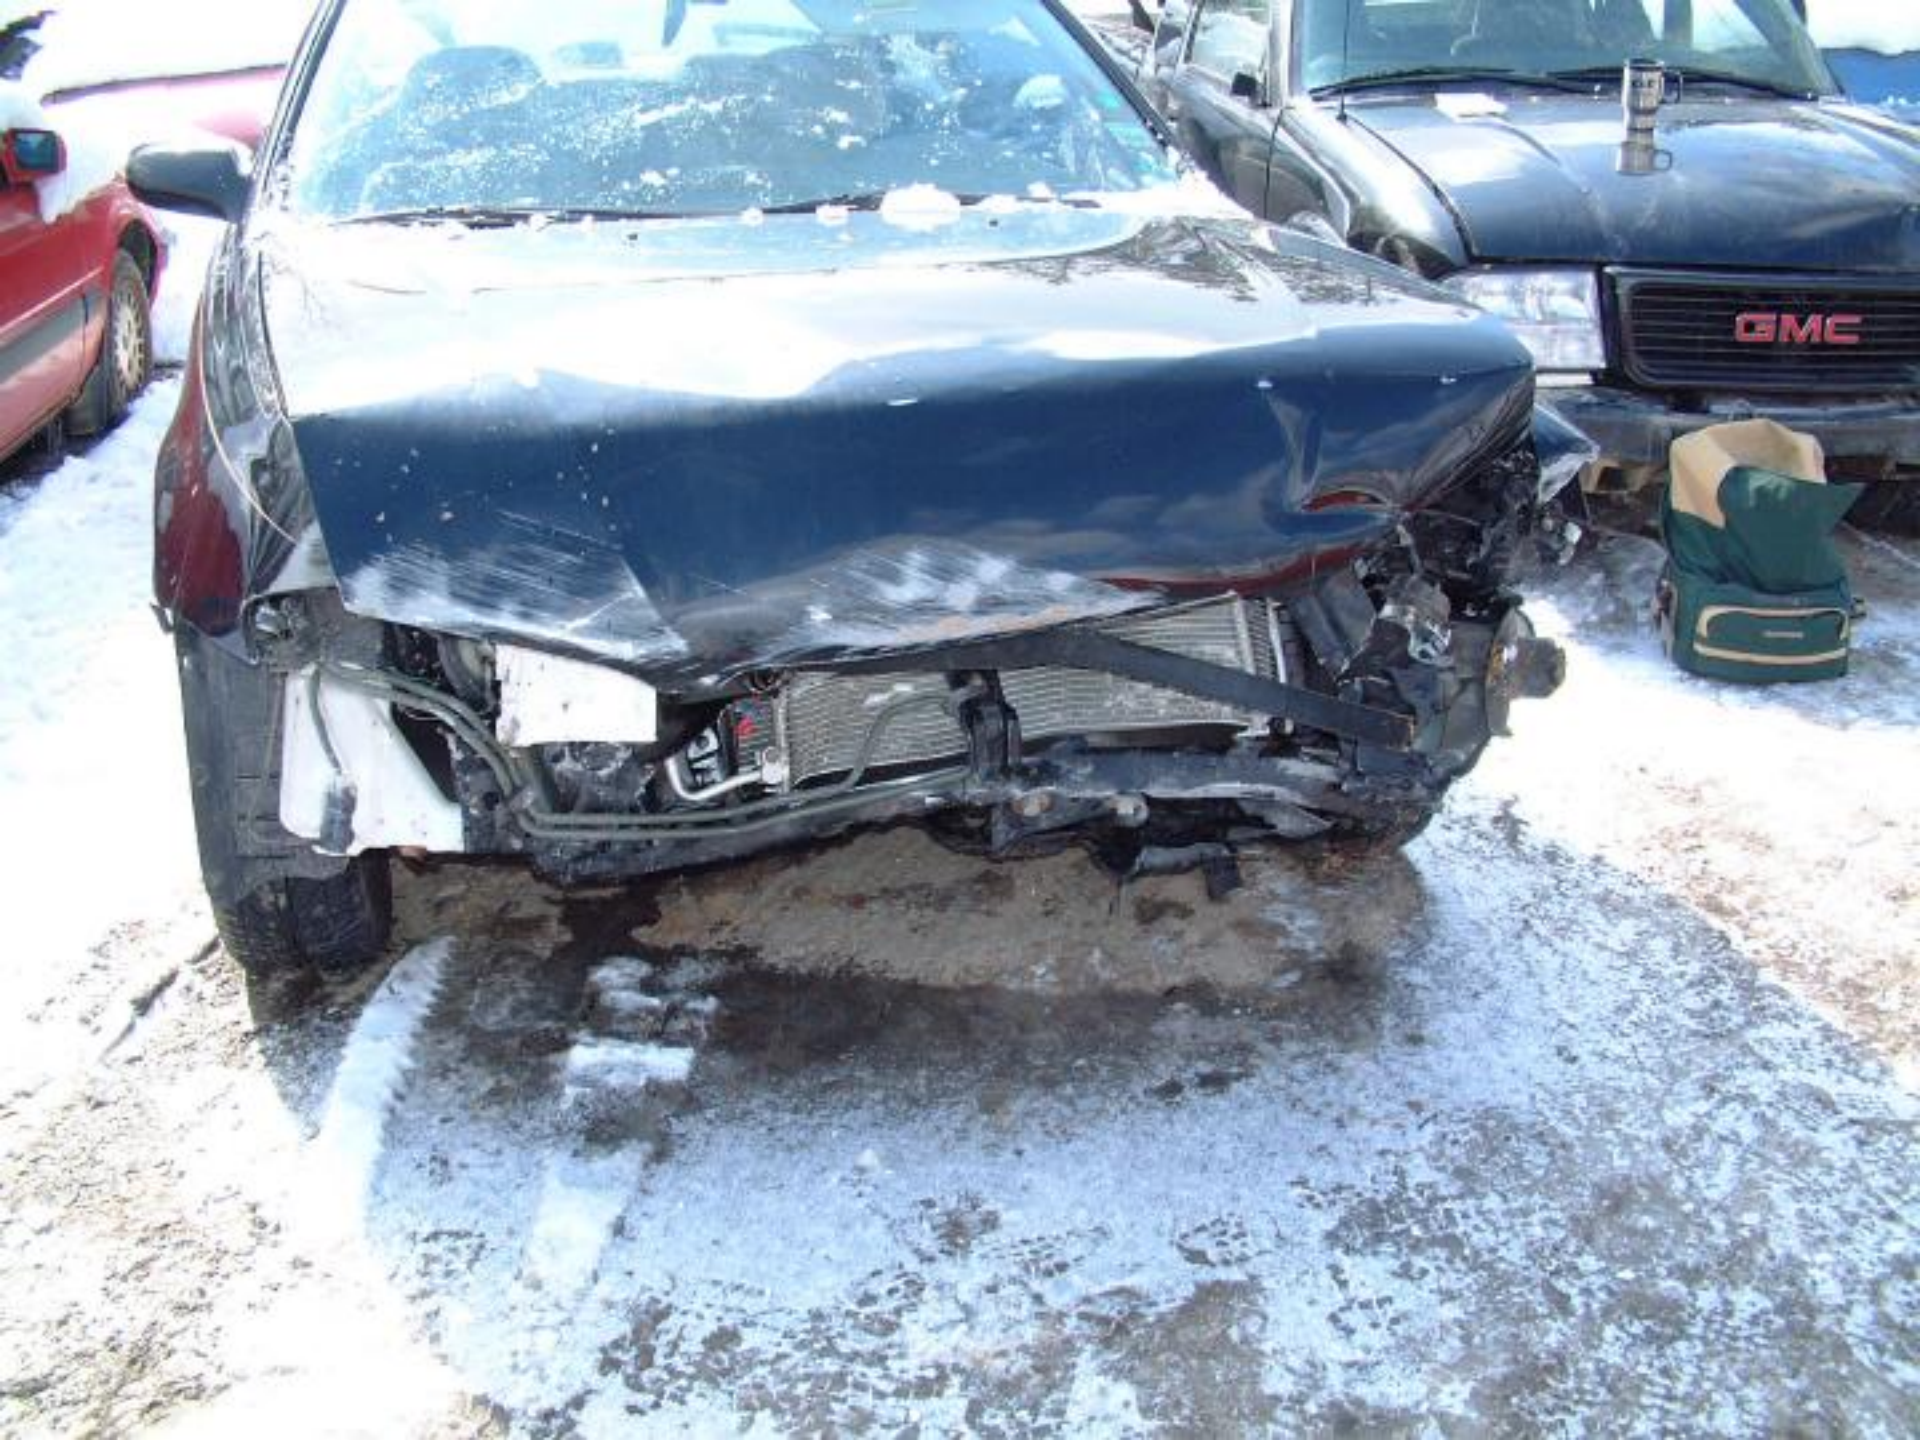
[18](#) [19](#) The right fender was crushed rearward and deflected to the left [18](#) but the right wheelbase was increased 7 cm. There was no damage to the right-side glazing. Both right doors remained closed during the crash and were operational.
